TECHNICAL ASSISTANCE TEAM FOR EMERGENCY RESPONSE REMOVAL AND PREVENTION
EPA CONTRACT 68-WO-0036

DATE: September 21, 1993
TO: Bonnie Green
FROM: Irmee Huhn
SUBJECT: Chase Interiors Site Assessment Report

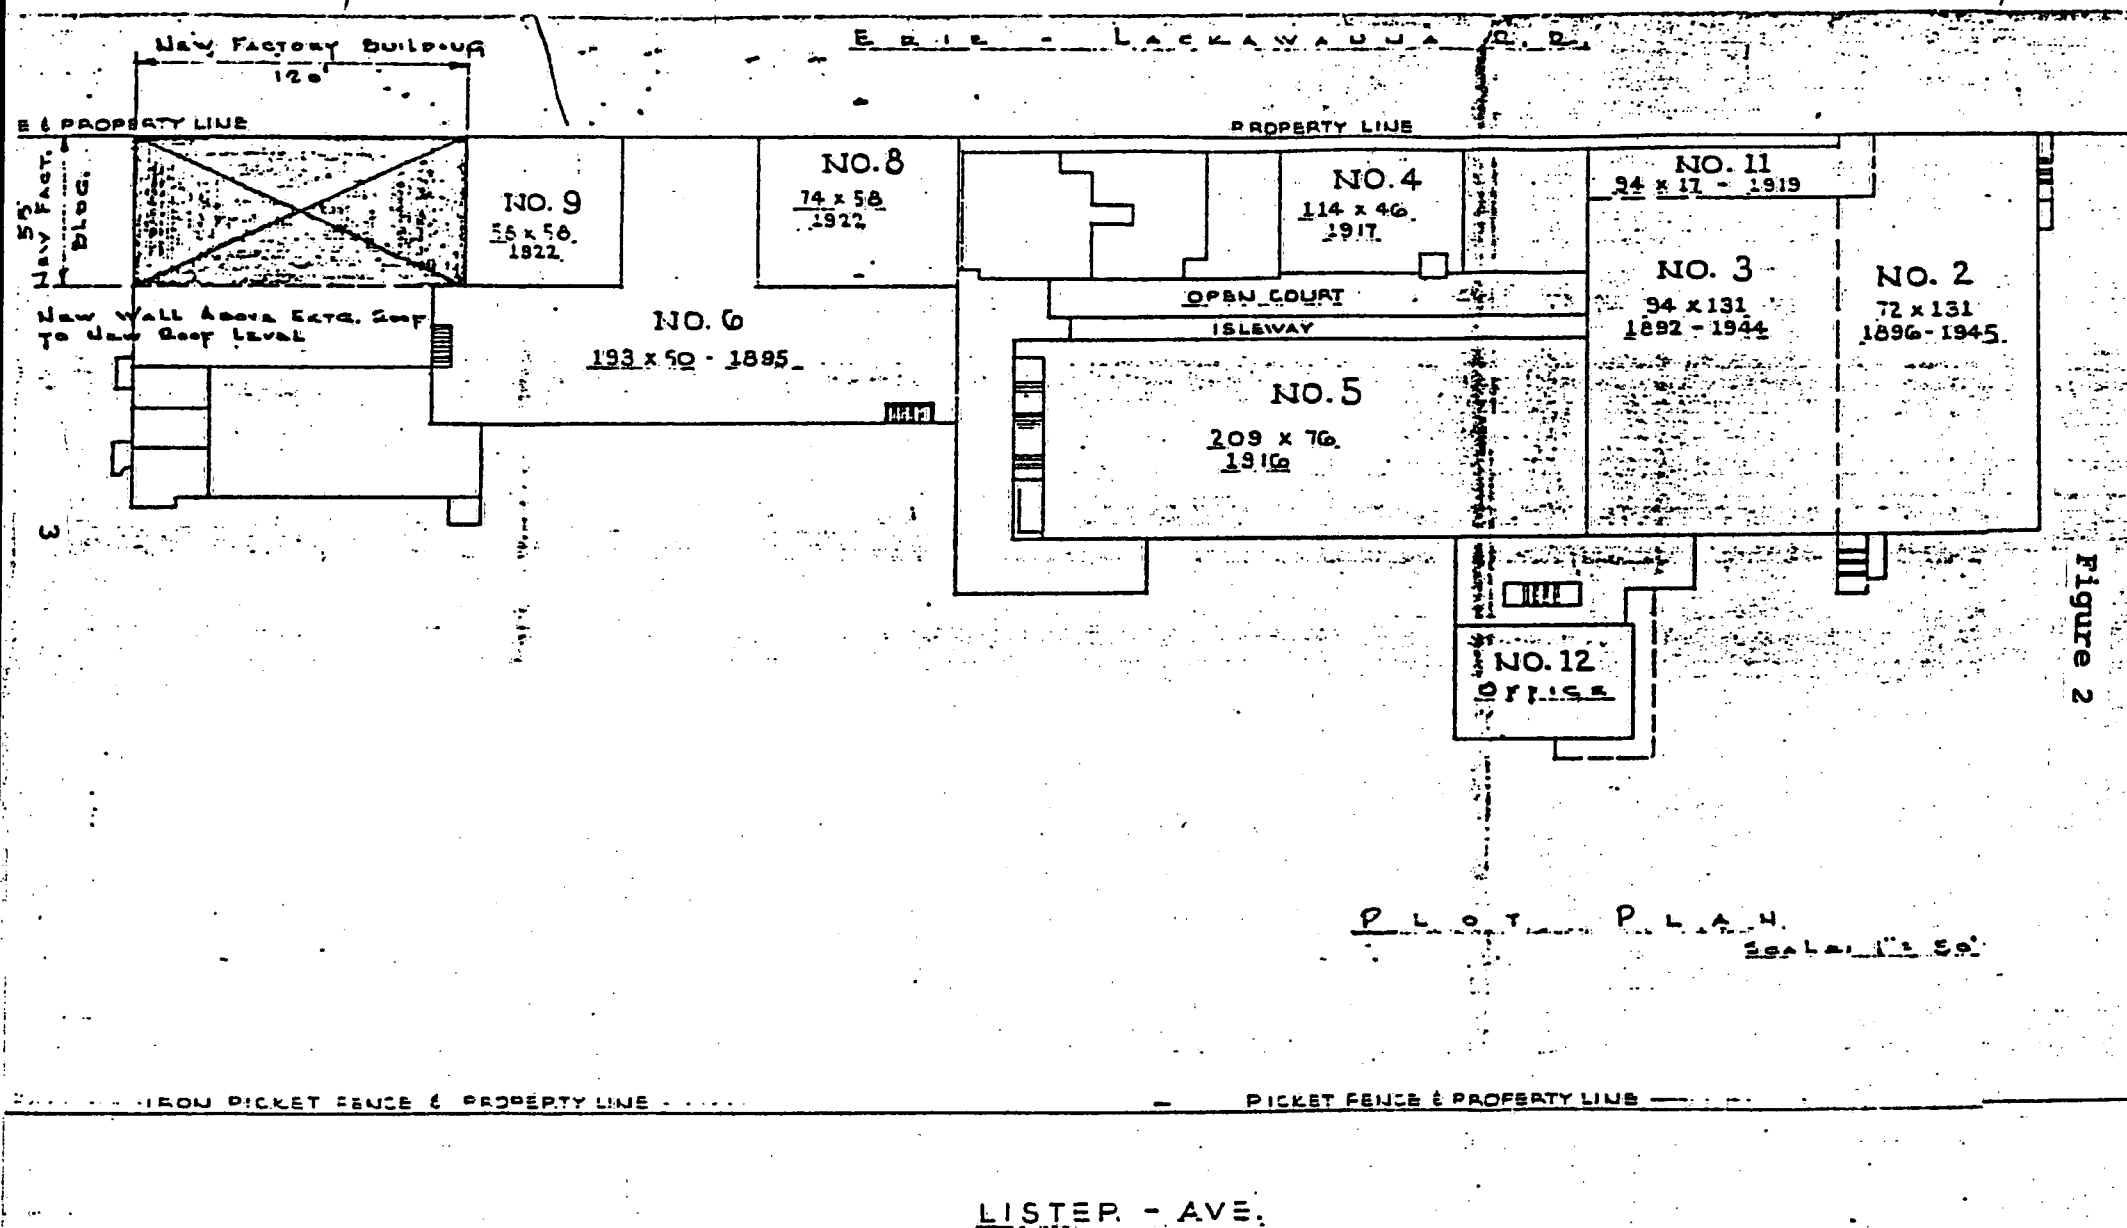
Figure 2

Based on available information, a significant threat to public health and the environment exists at the Chase Interiors Site. The potential for a release of hazardous materials exists, based on the types and quantities of materials present in the building, the deteriorated condition of many of the containers and the improper storage of the materials. The site is located in a mixed commercial/residential area and there are residential homes directly adjacent to the site (see Figures 1 and 2).

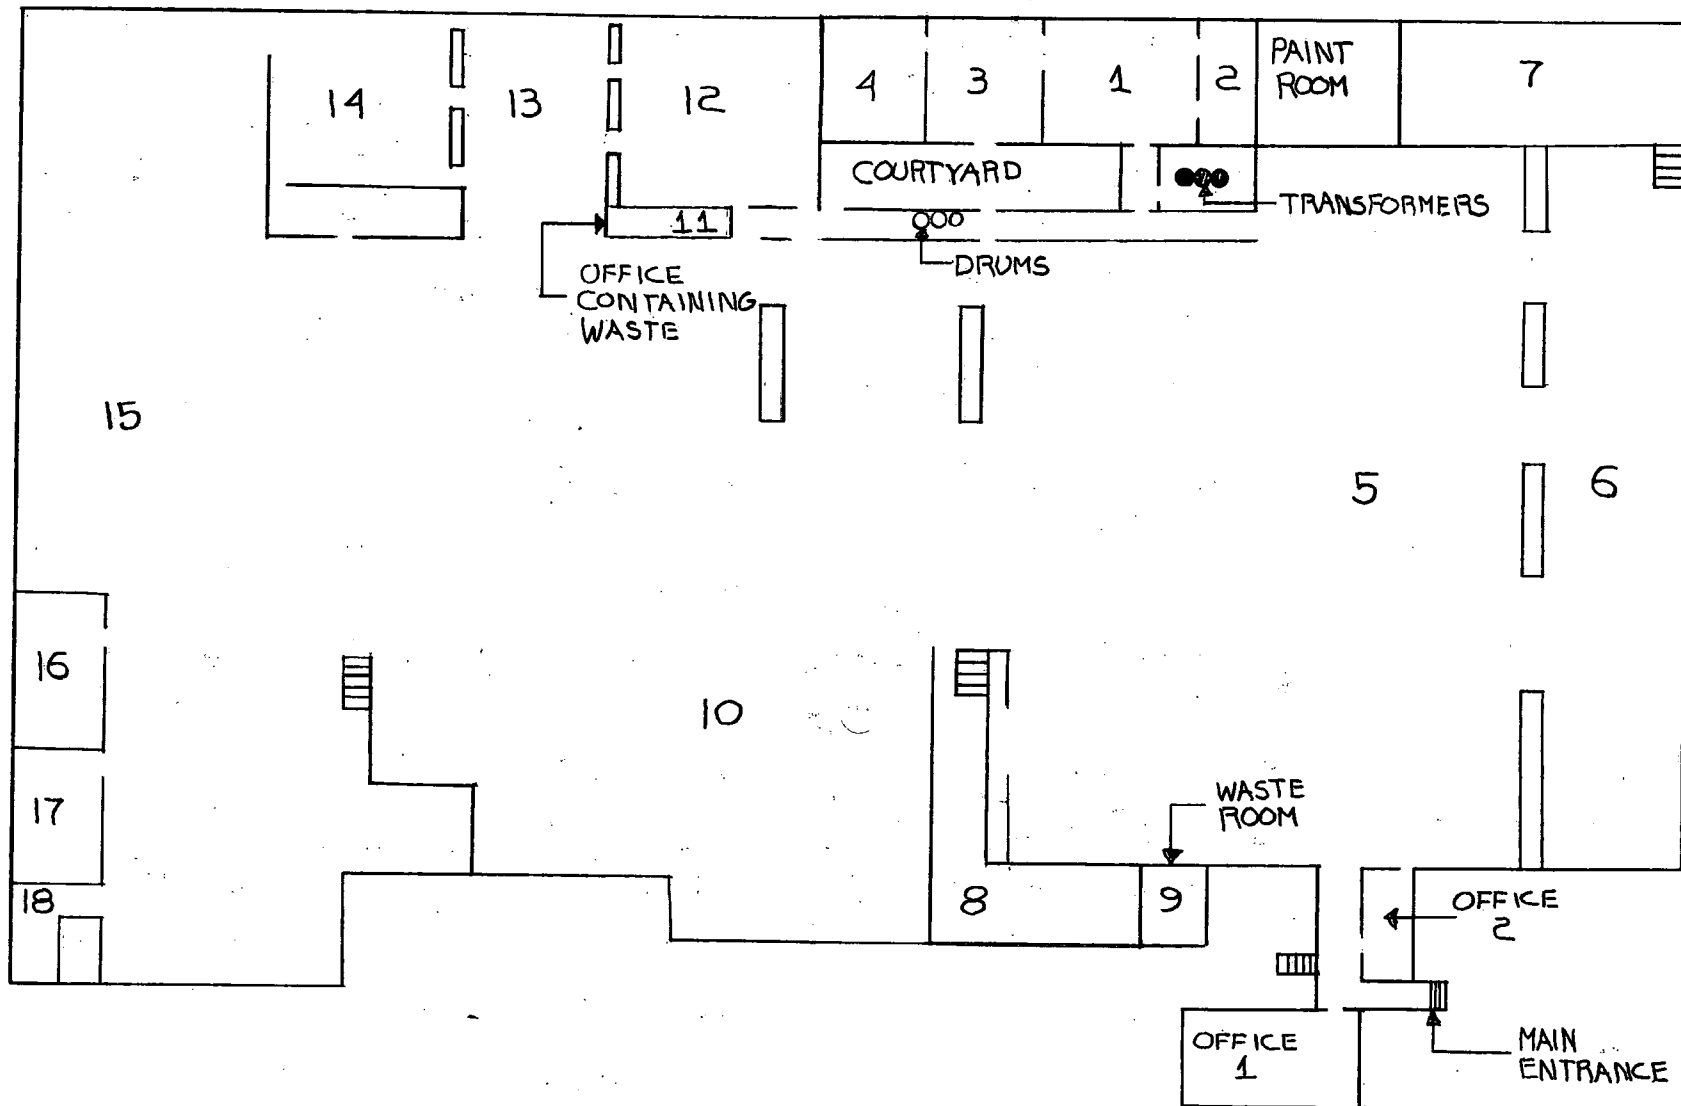
Figure 4

In general, air monitoring conducted in the main areas of the building using an explosimeter, photoionization detector (HNU-PID), Organic Vapor Analyzer (OVA) and radiation meter detected only background levels, however, there were elevated levels detected with both the HNU and OVA in the enclosed office room and in the paint room (see Figures 3 through 7).
